National Dam Inspection Program,
PA-RC & D-105 DAM

Basin, Thomas Creek, Susquehanna County,
Pennsylvania. PHASE I INSPECTION REPORT,

NAME OF DAM: PA-RC&D-105 Dam
STATE LOCATED: Pennsylvania
COUNTY LOCATED: Susquehanna
STREAM: Thomas Creek, a secondary tributary of the Susquehanna River
SIZE CLASSIFICATION: Small
HAZARD CLASSIFICATION: High
OWNER: Susquehanna County Commissioners
DATE OF INSPECTION: November 13, 1980 and February 5, 1981

PA-RC&D-105 DAM
ND1 I.D. PA-0979
DER I.D. 058-138
NOVEMBER 13, 1980

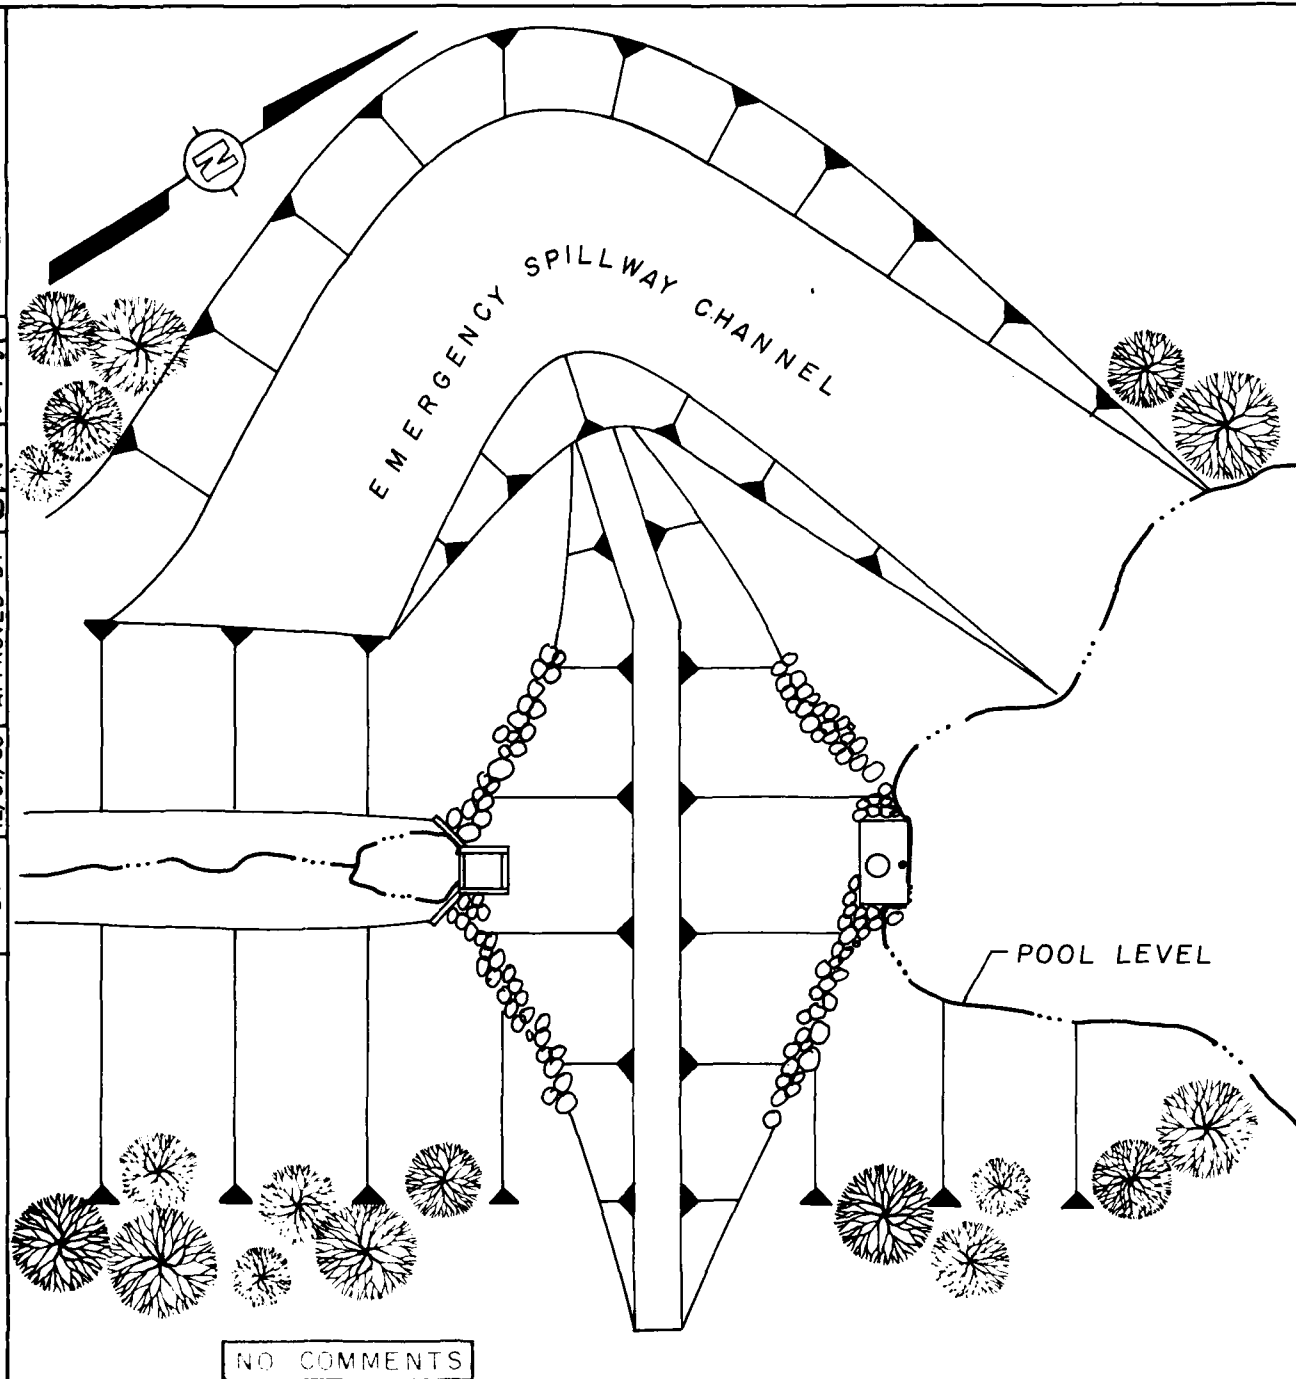
The top of the dam was surveyed relative to the emergency spillway crest elevation and was found to be within 0.2 foot of the design elevation with camber. Plate 11 shows the dam crest profile.

DAM CREST AT DATE OF INSPECTION
WATER LEVEL ~4" BELOW ORIFICE.
